Manhole Inspection Summary

Manhole # S02YY1014MH

Insp Date: **10/24/06 11:28 PM**

Location Address: **6400 park heights ave**

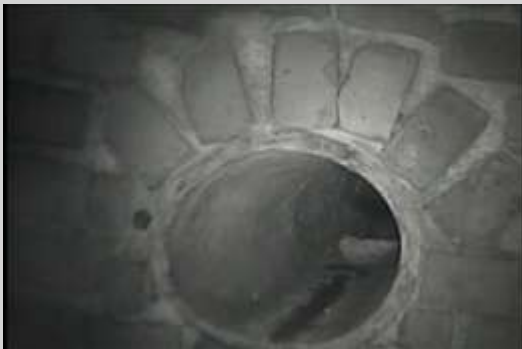
8 in. Circular Gravity Sewer Pipe In @ 7 O'Clock

Pipe Material: **Clay** ☐ Pipe Lined

Invert Depth: **6.48** (ft.) Flow Characteristics: **Fast**

Infiltration: **None** Pipe Seal Cond: **Sound**

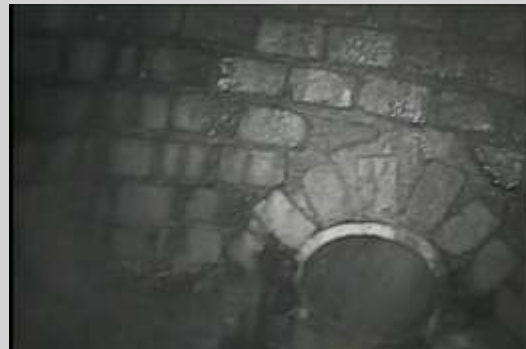
Drop In @ 7 O'Clock

Drop: **Outside** Rod and Bar

Angled: **Yes** Reading: **9.80** (ft.)

Inv Depth: **10.80** (ft.)

Drop Condition: **Open**

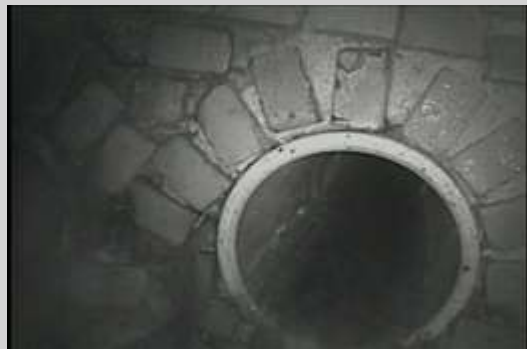
Pipe In @ 9 O'Clock

Pipe Material: **Clay**

Infiltration: **None**
